## ABANDONED SITE PROJECT

## FINAL DISPOSITION

West Bent Bolt  
8623 S. Dice Road  
Santa Fe Springs, CA 90670

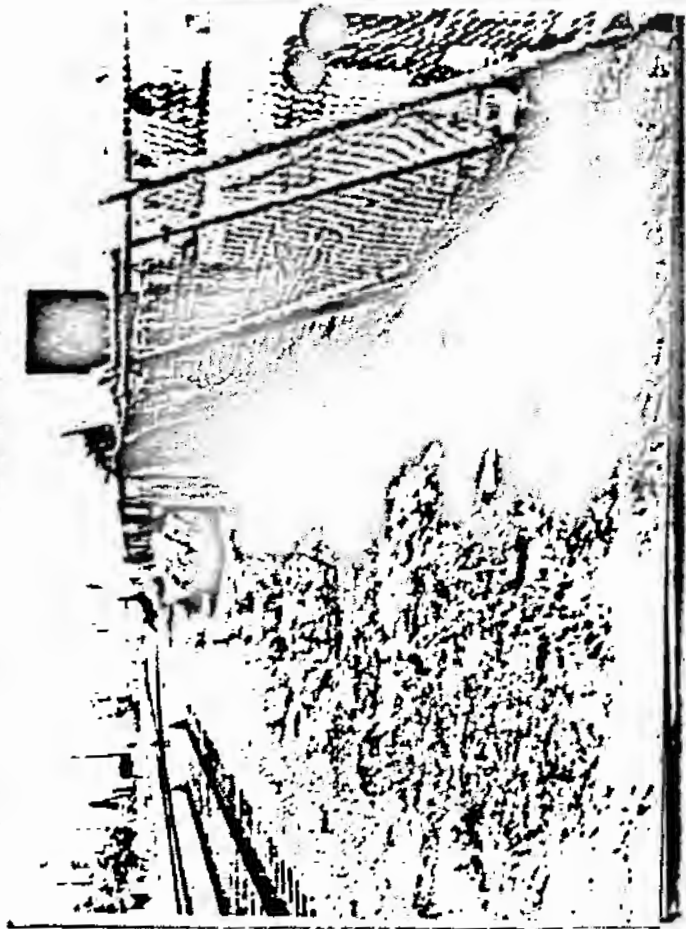
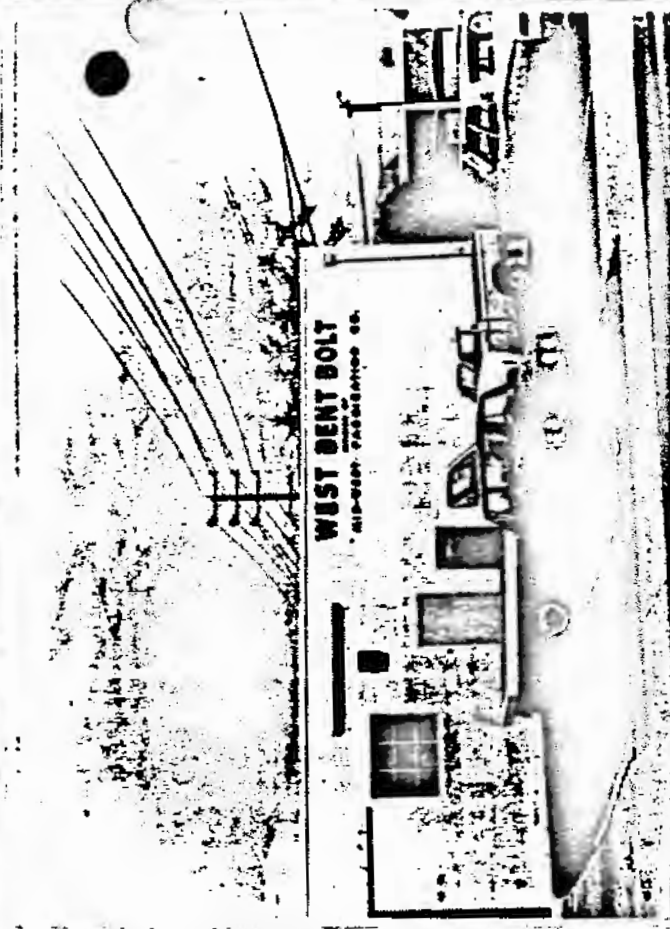
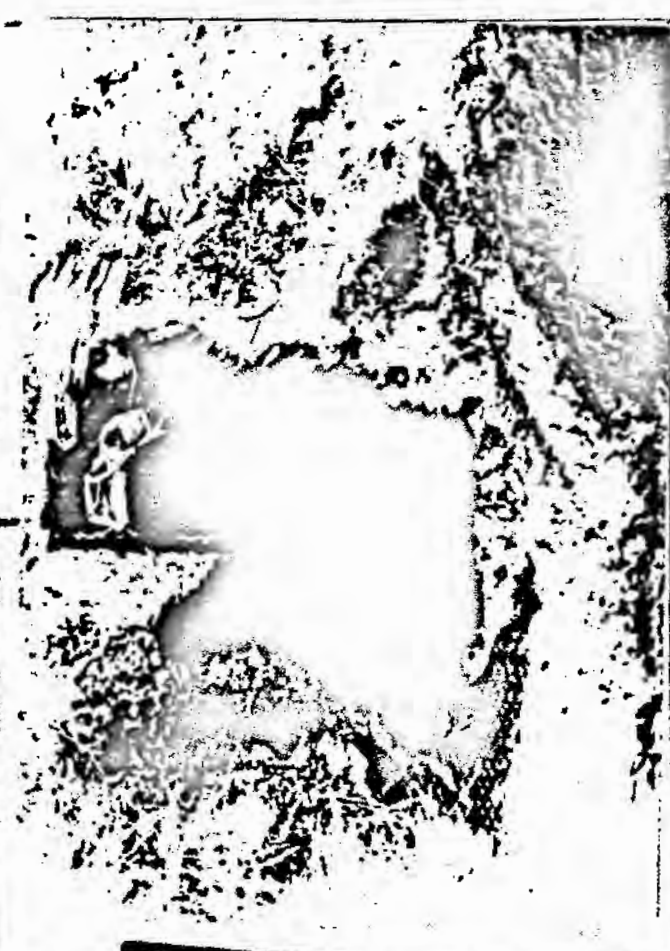
A field check performed by ASP staff on 6/17/82 discovered a culvert along the west fence containing a black substance. Soil along the railroad tracks was also discolored. Notice of violation and order to comply was issued 6/2/81 by LACE regarding this problem. Field checks performed on 2/27 and 6/17/82 confirmed that the problem still exists.

TYPE OF ACTION	NAME OF AGENCY OR CONTACT	TELEPHONE # OR ADDRESS	INFORMATION RECEIVED
Field Check 6-17-82	West Bent Bolt		<p>Problem still exists at this company. Dark oily substance in culvert noticed. A dead dog was noticed 30' from culvert.</p> <p>Photos were taken.</p>

The Abandoned Site Project staff have not sampled the site at this time. Core samples are required to determine the extent and composition of material present beneath the ground surface.
